Norris Bridge: Route 3 over Rappahannock River (#16)

Fredericksburg District

Age: 61
 Condition: Fair
 ADT = 9,000
 Detour: 90 miles
 Length: 1.9 miles

Large Complex Structures - Major Projects in 30-Year Plan

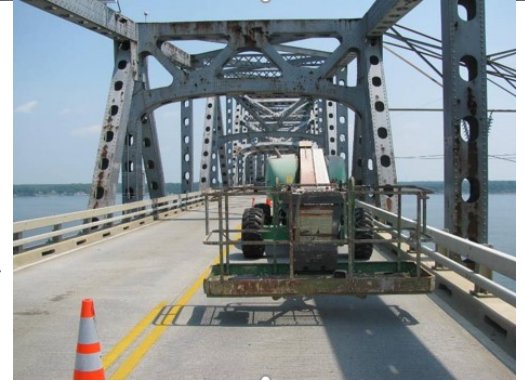
The Robert O. Norris Bridge (Norris Bridge) carries Route 3 over the mouth of the Rappahannock River. The bridge is fracture critical, which means that failure of a primary structural member could lead to a collapse of the structure. The structure also includes a large number of “pin and hanger” assemblies. These assemblies provide no redundancy (alternate paths for loads) in the event of failure. Structural repairs to steel beams and other support members are required for the safe operation and functionality of the bridge.

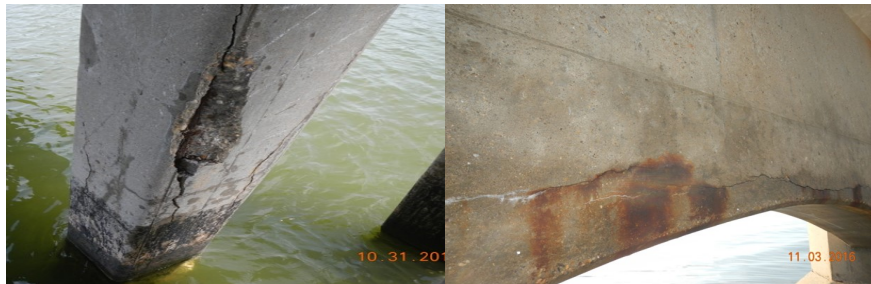
The substructure (concrete piles and piers) is subjected to saltwater, which permeates the concrete and attacks the reinforcing steel, causing corrosion and deterioration. The damaged concrete in the piers will be removed and replaced where necessary. Piles requiring repair will be addressed with pile jackets.

Pile jackets are a protective and restorative treatment that improves the condition of the pile while slowing the rate of the deterioration. Jackets are placed over the piles in a region known as the “splash zone”. This zone begins just below the waterline and extends several feet above the portion of the pile that is routinely exposed to water. The jackets are filled with concrete, adding strength and protecting the pile from further infiltration of water. The jackets also include systems that protect the native pile by slowing the corrosion rate of its reinforcing steel. Pile jackets have a limited service life but can be effective preservation treatments for bridges with permeable concrete substructures. The photographs below show pile jackets during and after installation.
